SECTION 1 – INTRODUCTION

PRINCETON PLACE I ON WIGGINS BAY

Report Date:
January 17, 2024

1.0 INTRODUCTION

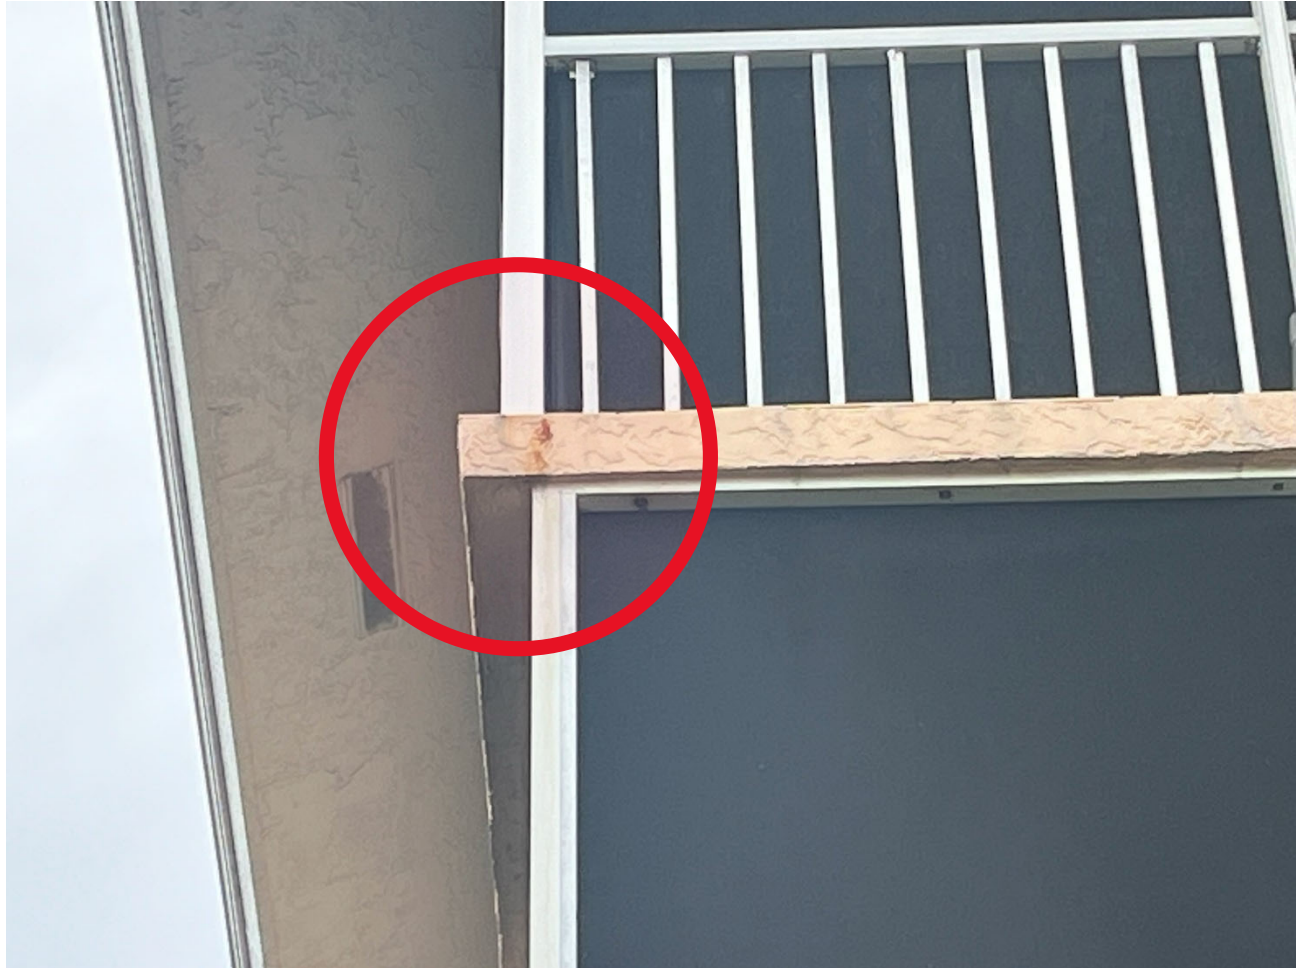
Rust Streaks on Lanai Slab

There were rust streaks on the concrete slab edge of the top corner unit on the 4th Floor (#408). These indicate that water is somehow getting into the concrete to cause the rusting. Left unchecked, this condition will eventually lead to spalling of the concrete (a condition where a large piece of concrete has been pushed out by the rust which expands the internal steel rebars). Inspector suggests that the source of the rust be identified and seal up any openings where water is being allowed into the concrete above this location. Effective water proofing will prevent the water intrusion and the deterioration of this concrete slab in the future.

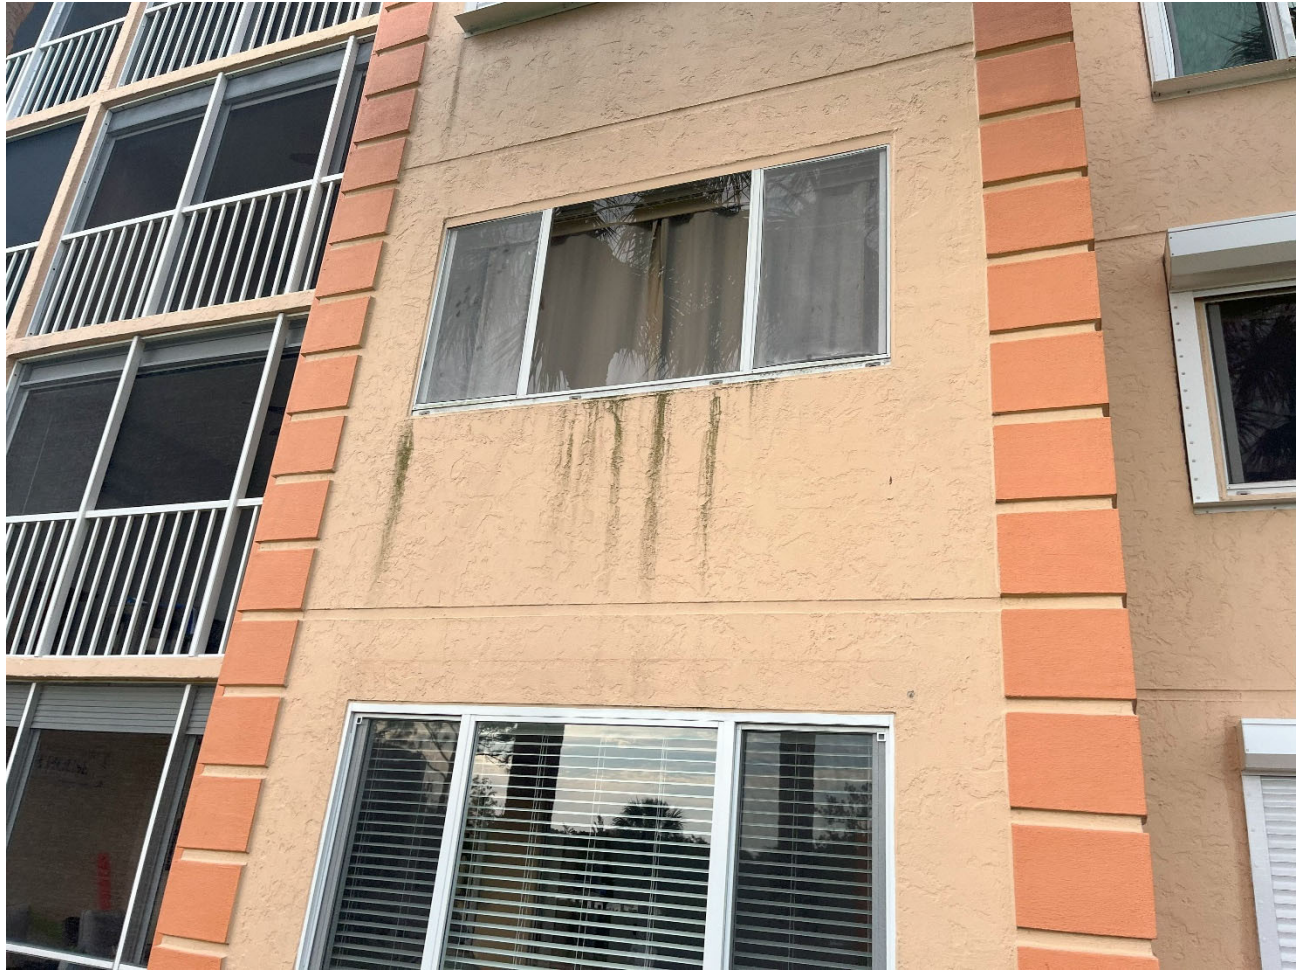
Dark Streaks on Stucco

The dark streaks observed in the photo below were not present anywhere else on the exterior of the building except outside Unit #205. These may be caused by an accumulation of dirt in the tracks of the sliding windows but a qualified window technician needs to investigate this more closely to see why this is happening and suggest a fix to prevent it in the future.

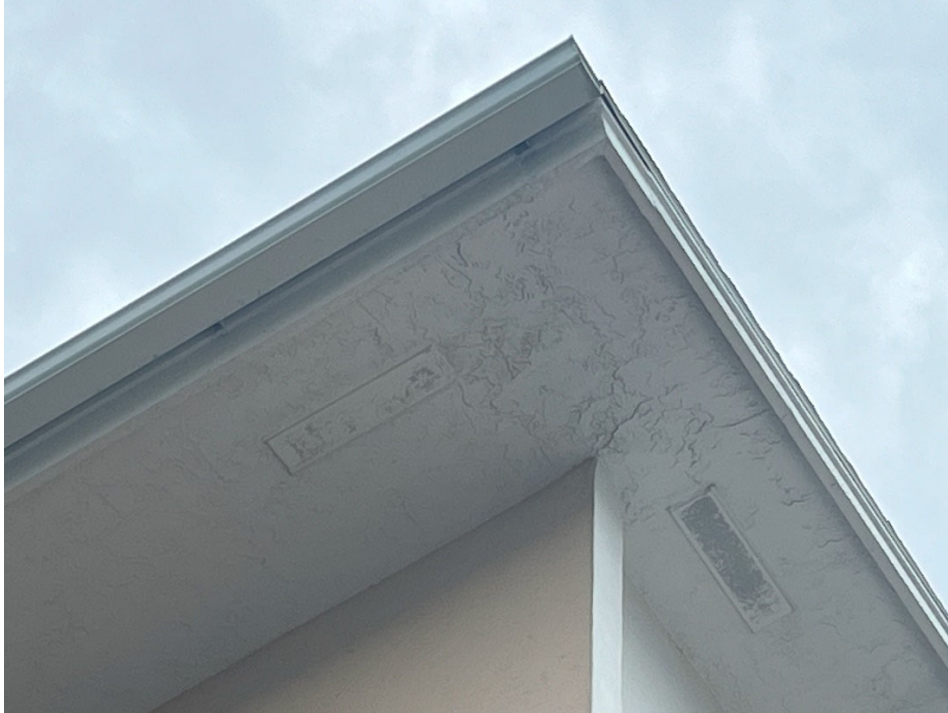
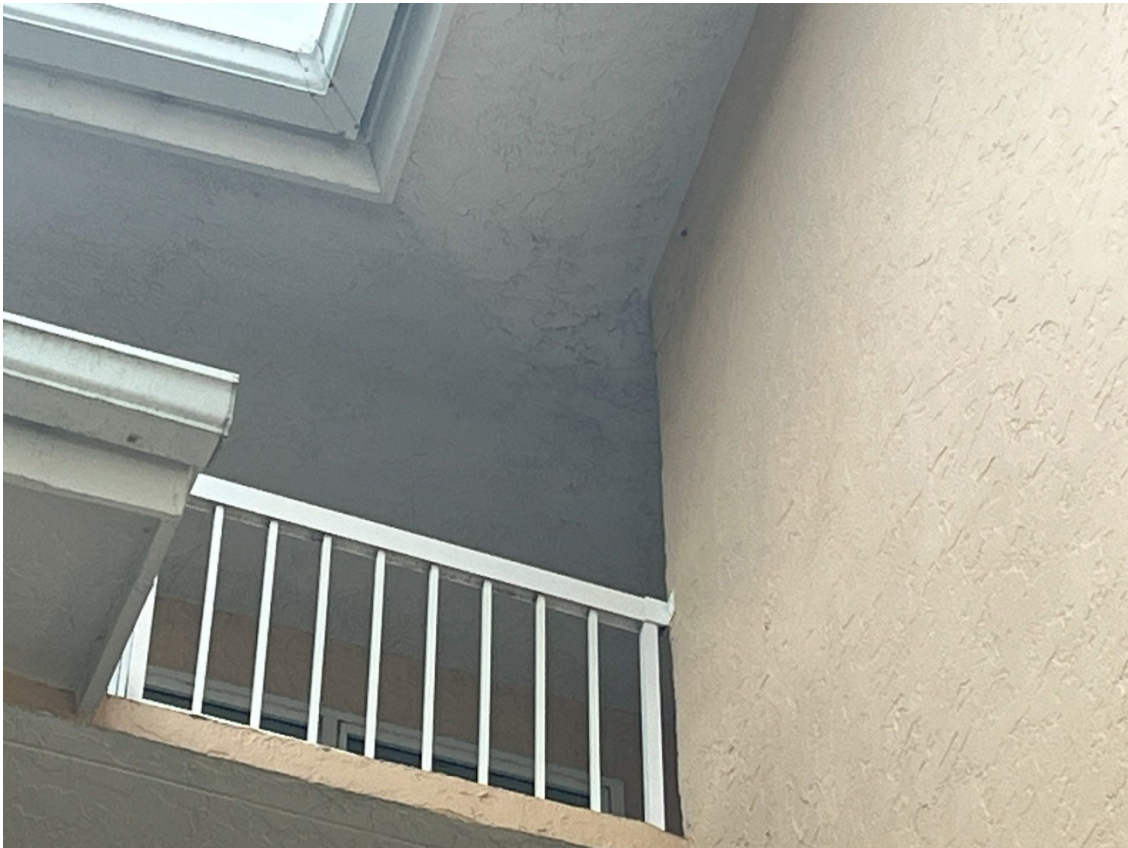
Soffit Condition on the 5th Floor

The soffits in the photographs below were taken on the 5th floor near the left end of the front of the building. It appears the soffits were patched in this area. This area may have a few hairline cracks that could allow water in to wood substrate materials and degrade them over time. Suggest having a qualified stucco technician review these areas to be sure they are weather tight.

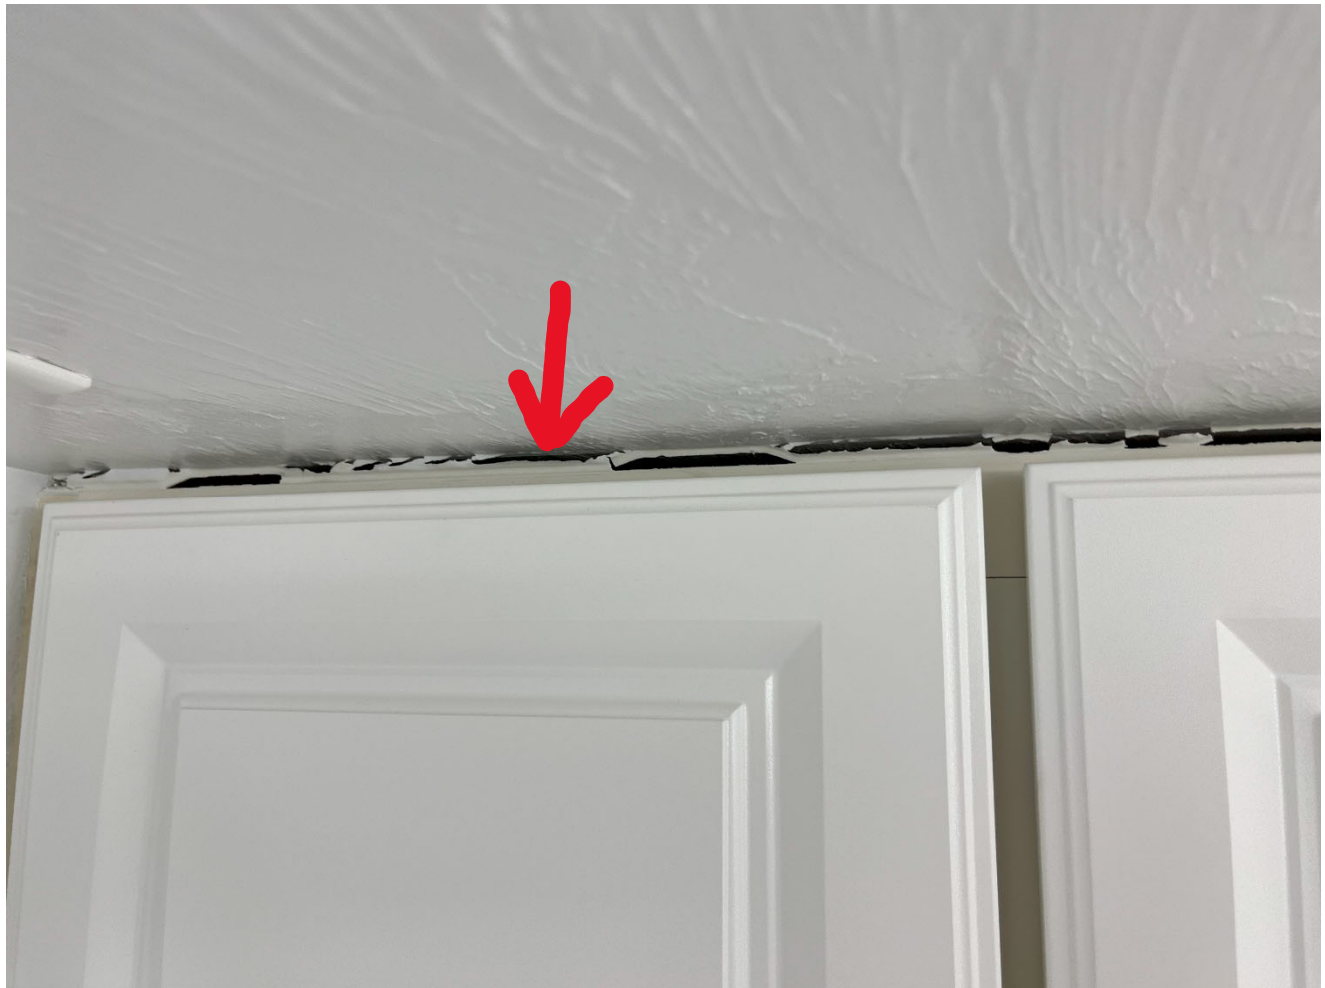
Unit 107 had a crack at the top of the cabinets in the Laundry. It appears the cabinets may have settled over time but it needs to be determined that they are securely fastened to the wall and not in danger of falling. If fasteners appear sufficient, then caulk crack and monitor to see if it attempts to open up again in the future.

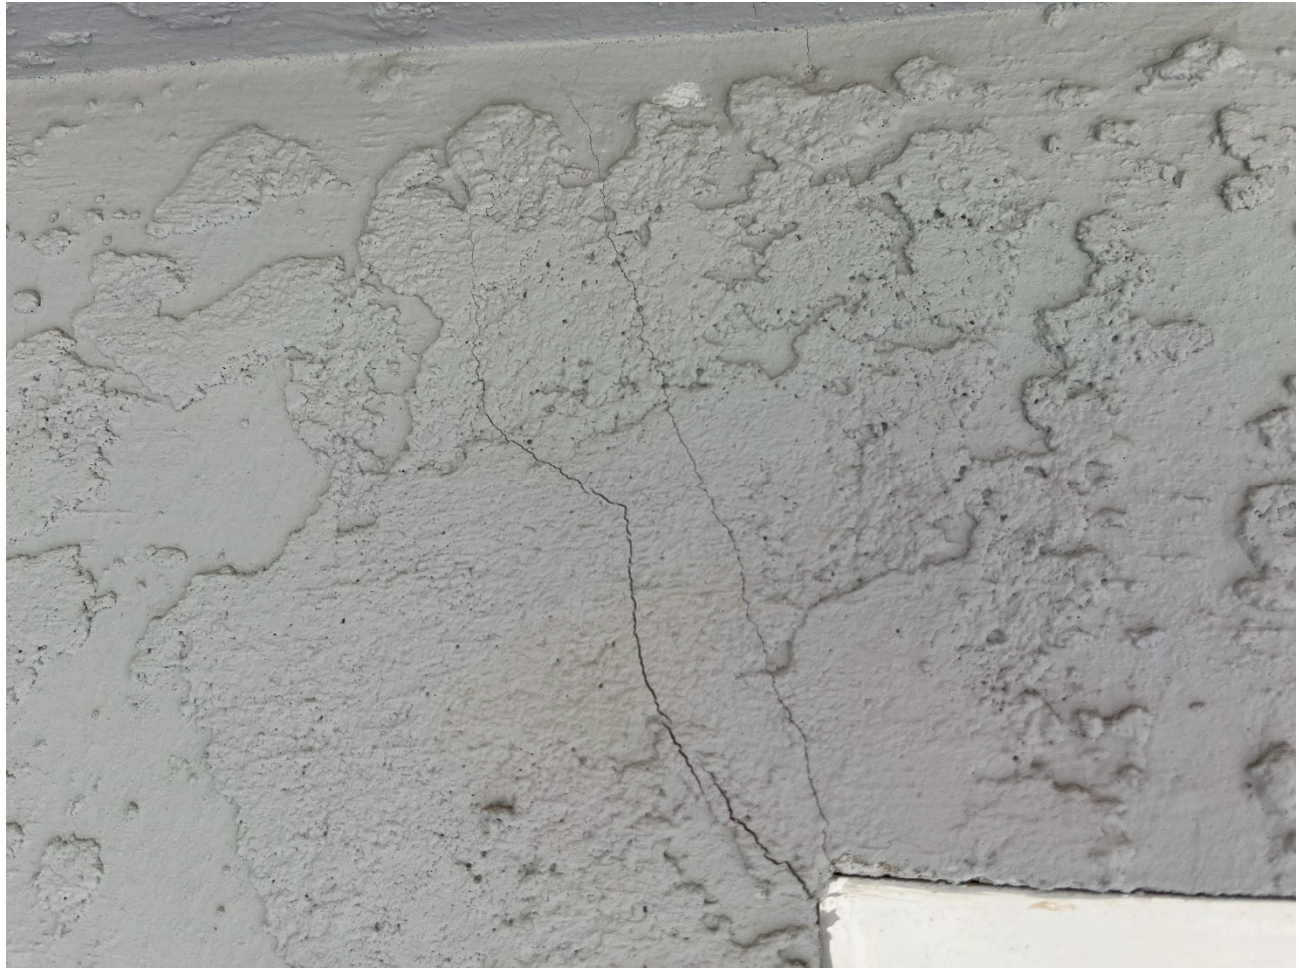
This Unit 107 also had some diagonal hairline cracks in the stucco from the top left corner of the door opening. Since this is an outdoor area, it is important to keep all such cracks sealed from the elements no matter how small. Have a competent stucco technician fill and seal these cracks.

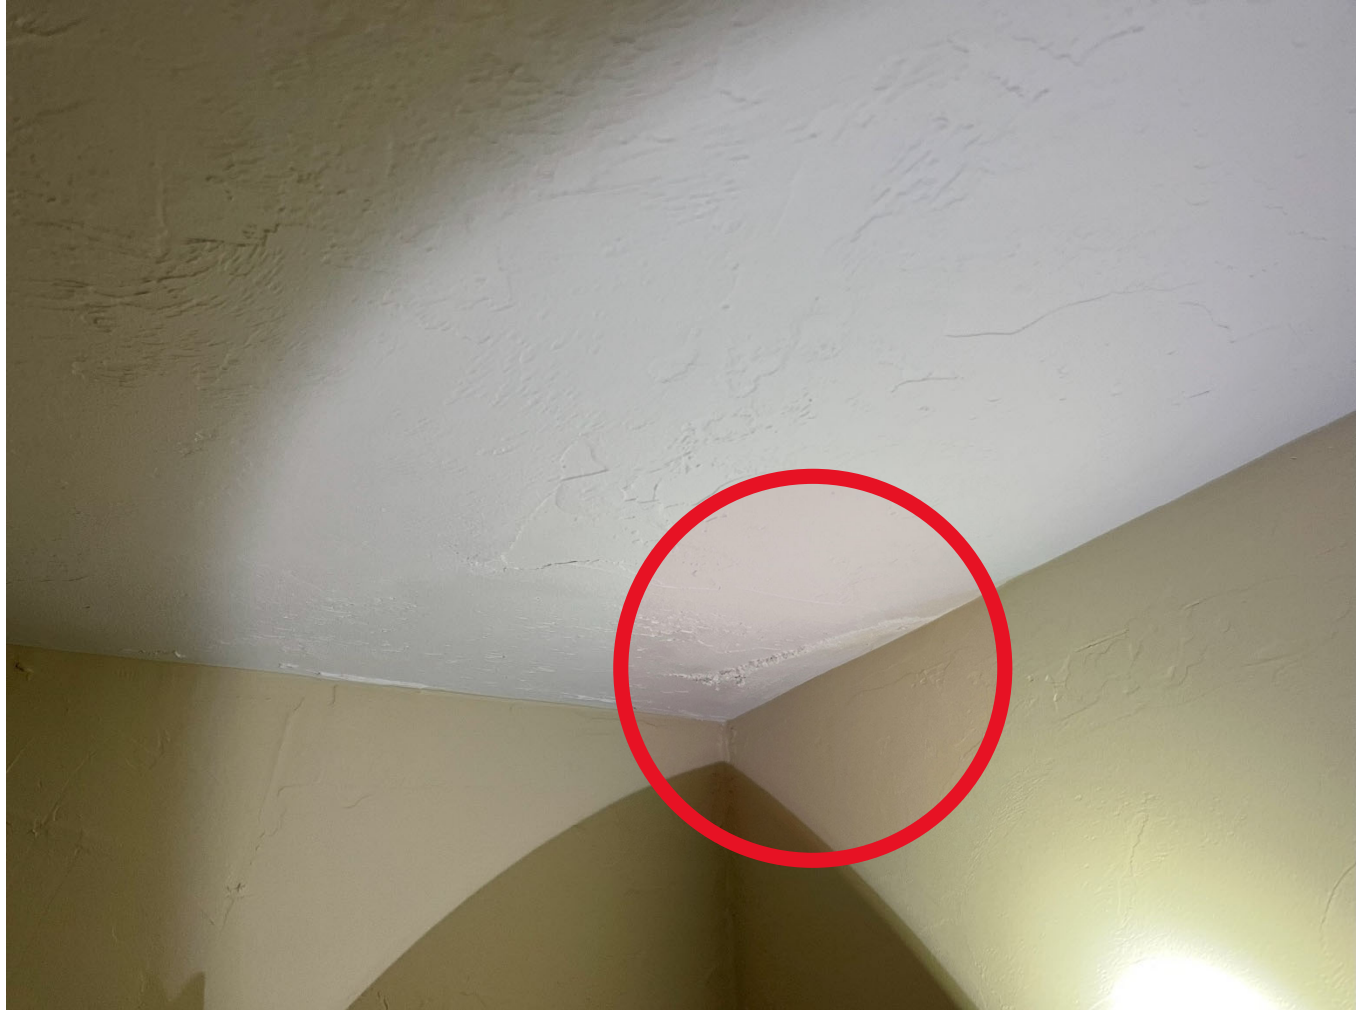
Unit 206

This unit had evidence of water penetration on the ceiling of the Master Bedroom near the corner. May have been the result of past roof issues which have been resolved. Suggest having this area repaired and monitored to see if water stain reappears.

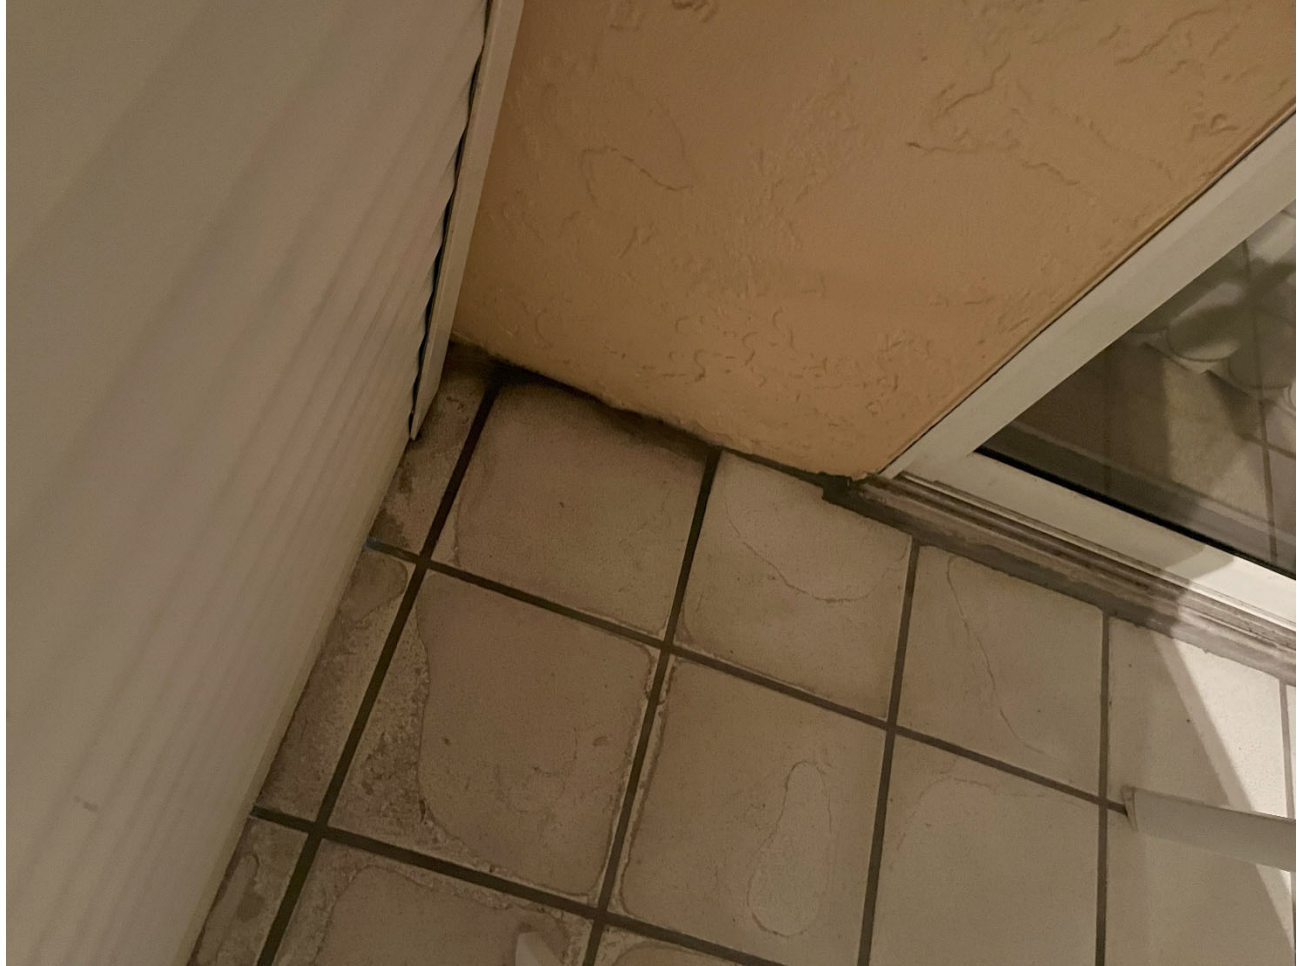
Unit 207 had evidence that water was ponding on the lanai. This can lead to water migrating down into the supporting concrete slab below and rusting the rebar resulting in spalling. See that any available weep holes are free and clear so water can flow off the lanai. If no weep holes are present, inspector suggests drilling some in the area where water seems to be ponding the most.

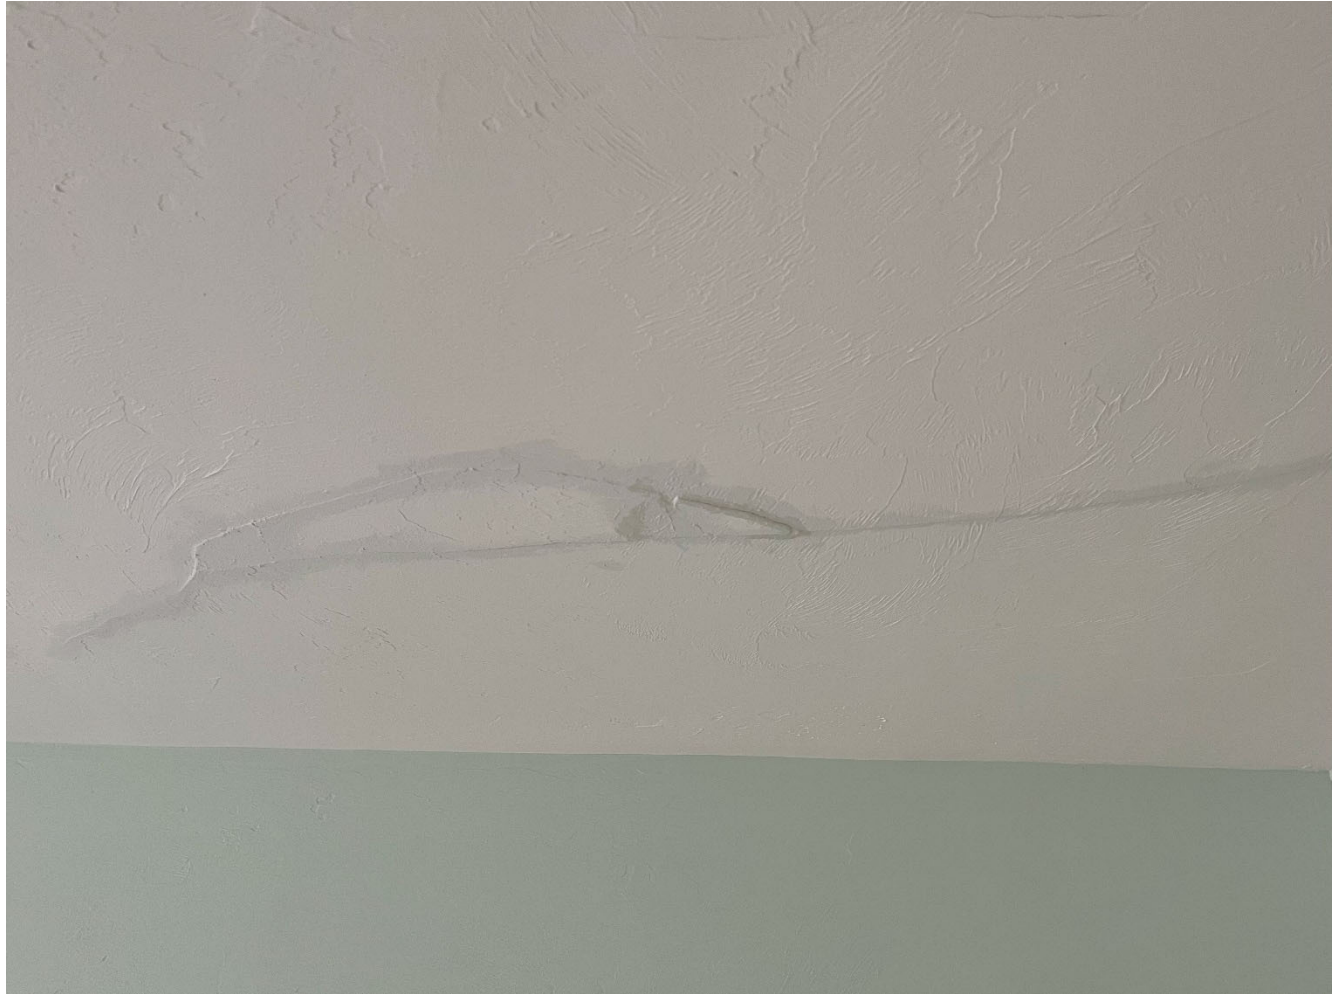
Unit 303 had a strange shaped crack in the ceiling of the Guest Bedroom. There was an attempt to reseal the crack but the source of this anomaly should be determined. If it is determined that what caused this crack has been determined and corrected, suggest effecting a better repair of the area. Once repaired, monitor this area to see if any additional cracking becomes evident.

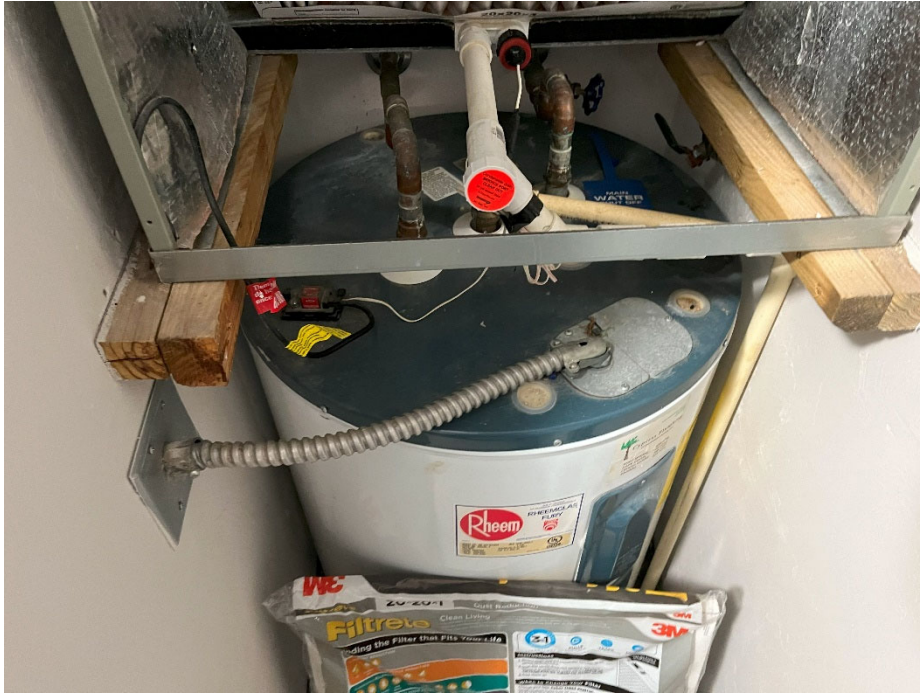
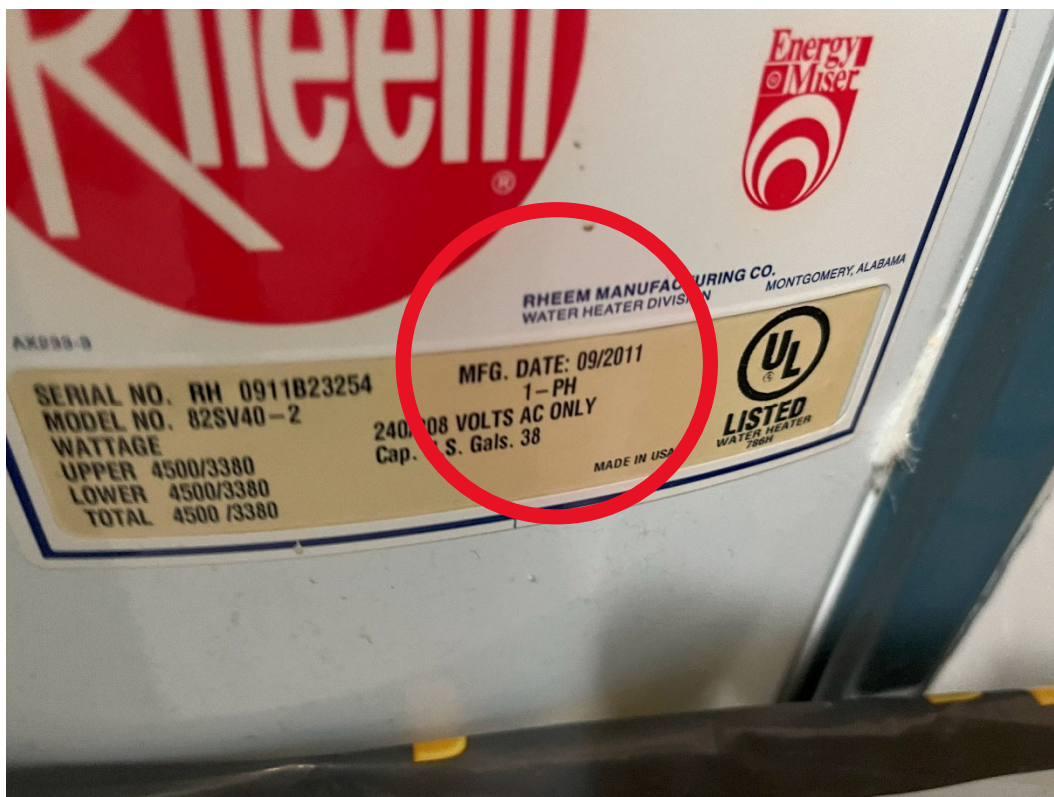
Unit 307 had a water heater that was dated 2011. In multi-unit buildings like this one, it is advised to replace water heaters every 12-15 years to avoid tank failures and subsequent flooding of this unit and the ones below it. This water heater is 13 years old so it is inside the suggested replacement time window. Recommend that unit owner replace this water heater in the next year or two. Suggest having all water heaters in the building observed for age and replace any that are outside the suggested time period.

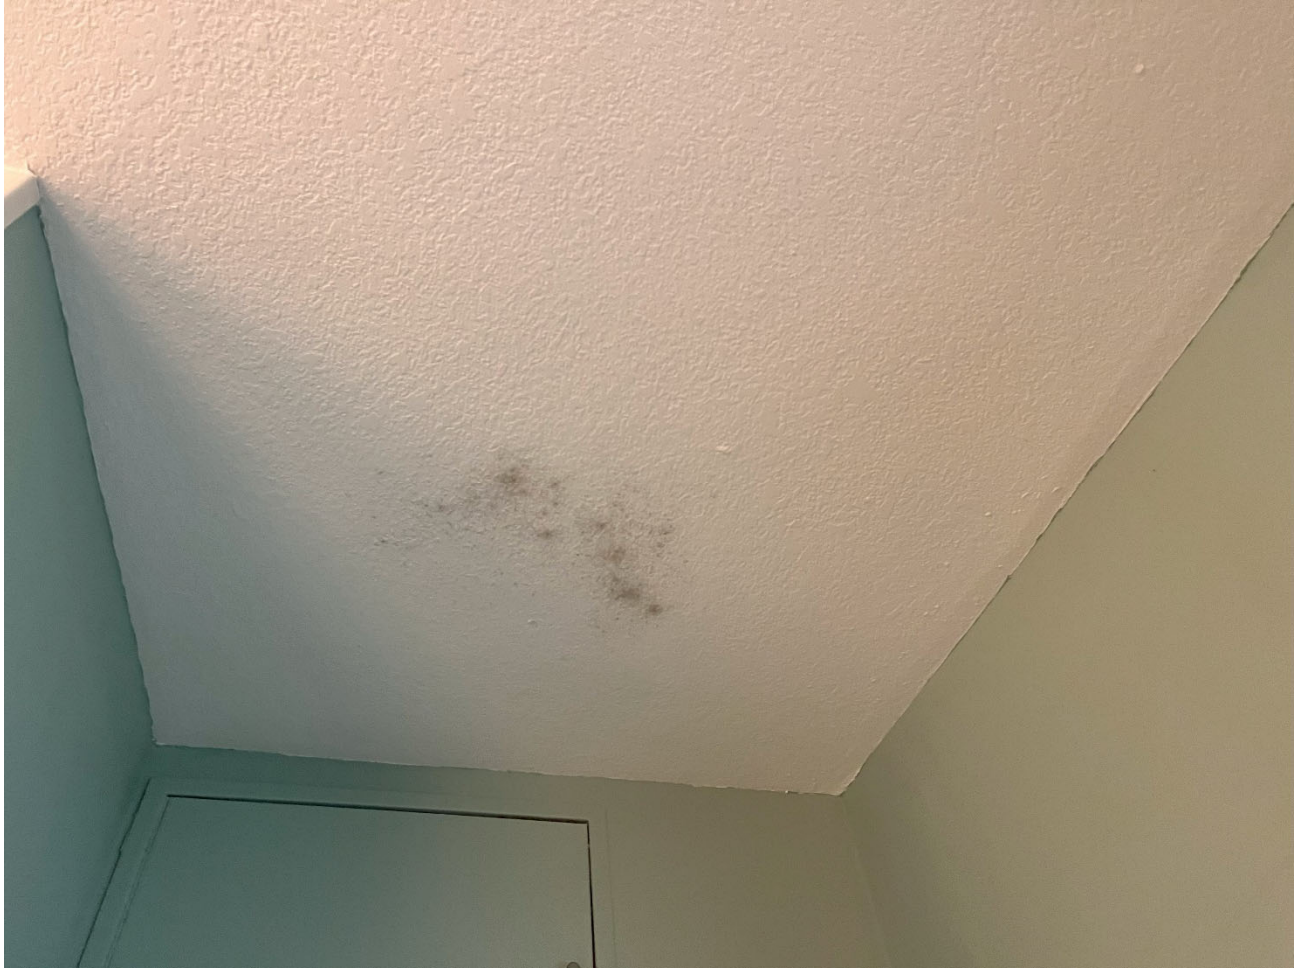
Unit 401 had a stain on the ceiling of the Kitchen that appeared to be a former water stain, most likely caused prior to the replacement of the current roof. Suggest having this stain painted over and then monitored to see if the stain attempts to reassert itself.

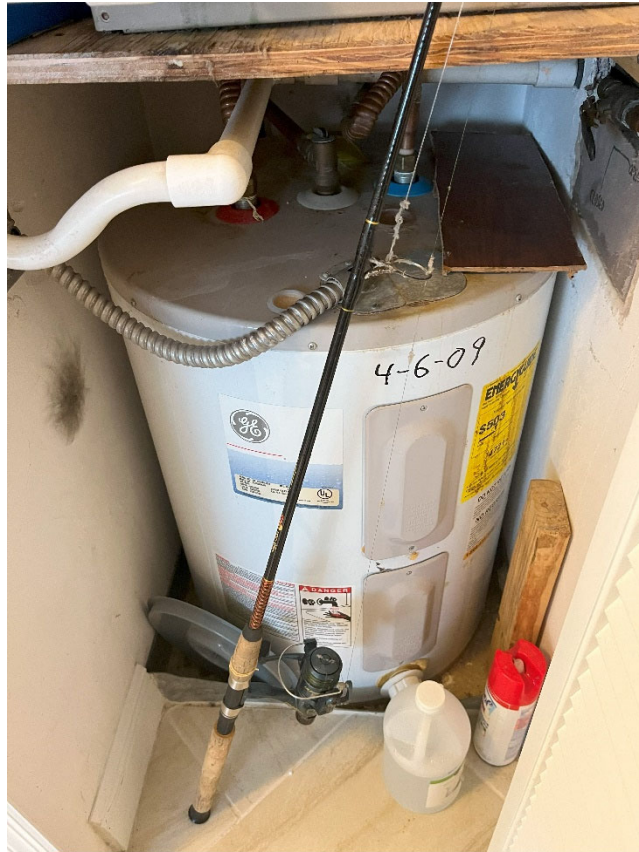
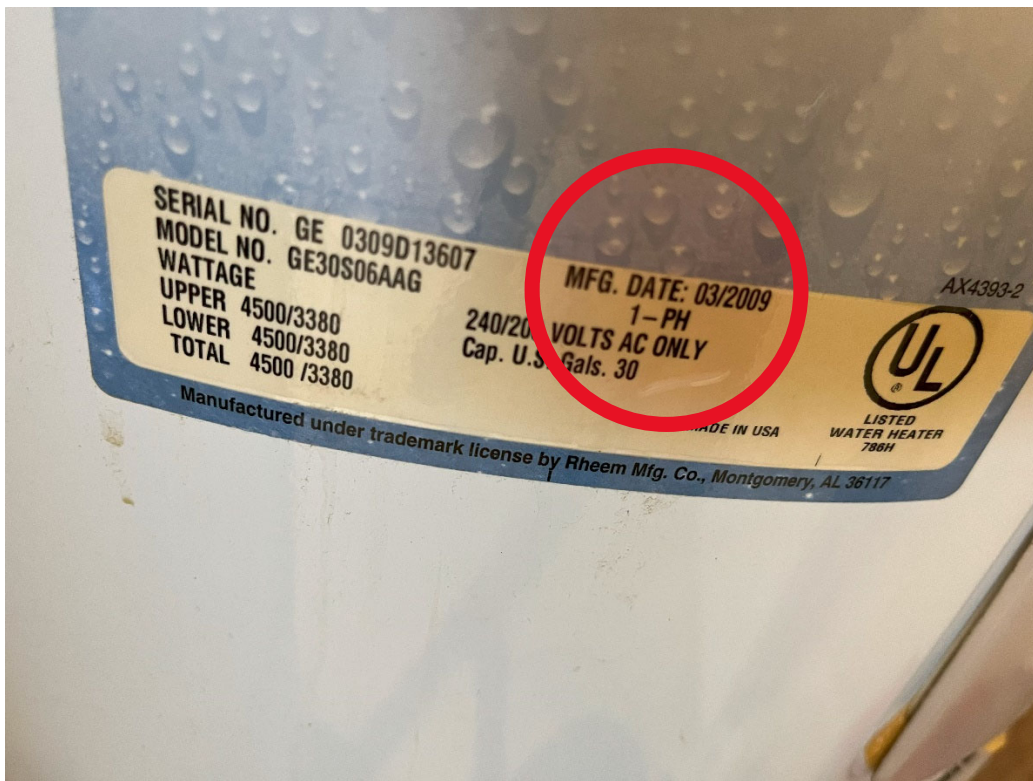
Unit 401 (Cont.)

Unit 401 also had an aged water heater dated 2009. This unit will be 15 years old this year so suggest replacing it in the near future.

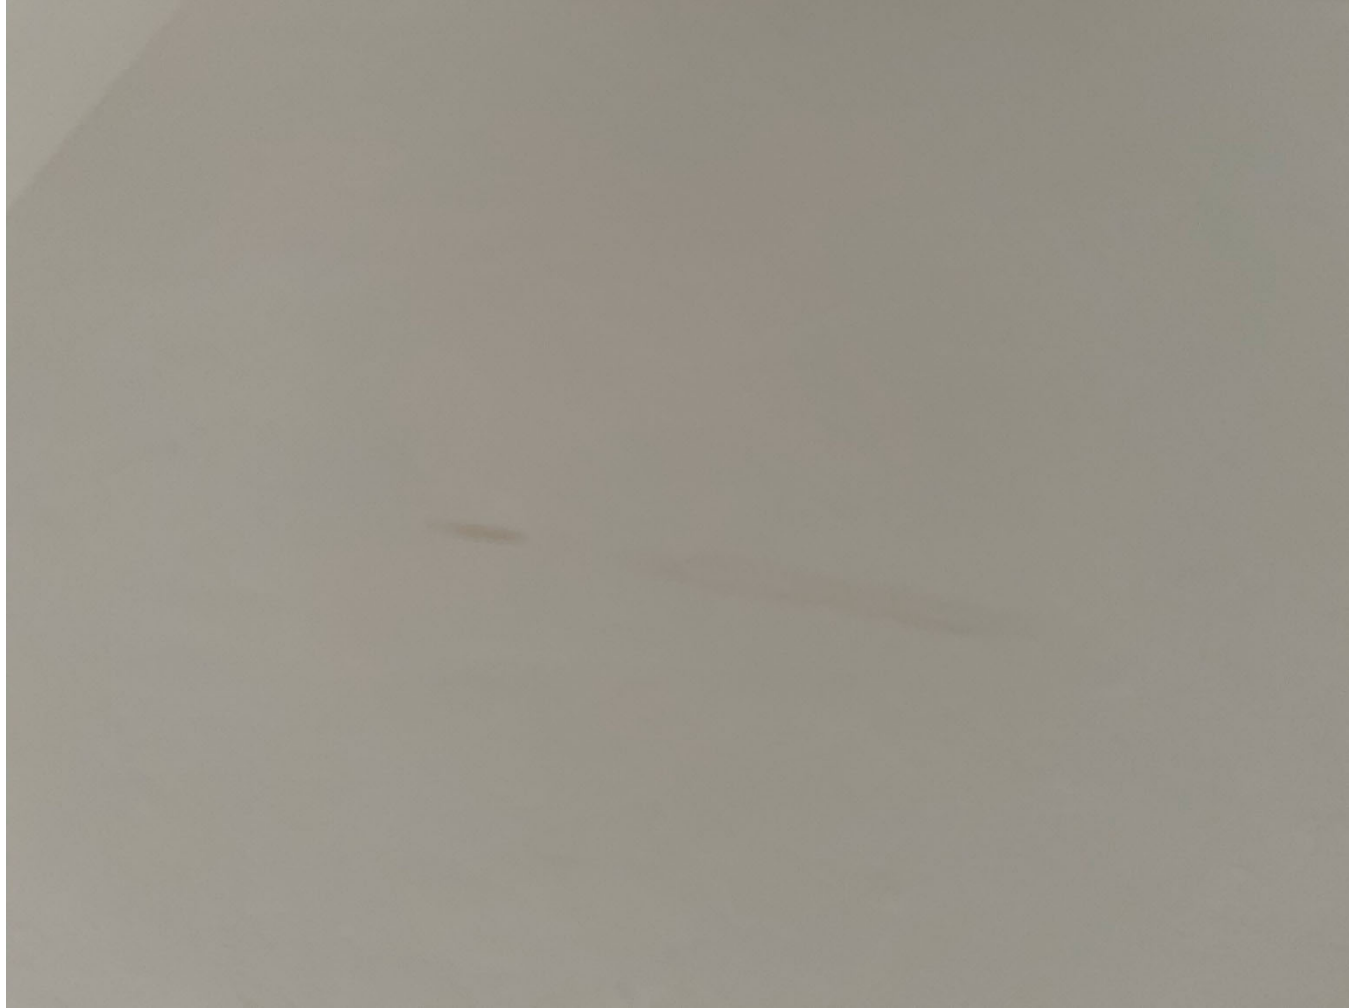
Unit 502 had a stain on the Master Bedroom ceiling. Since this unit is on the top floor, it was most likely caused by a roof leak that was probably corrected when the new roof was installed in 2017. Suggest painting over this stain then monitor it for any signs of reappearance.

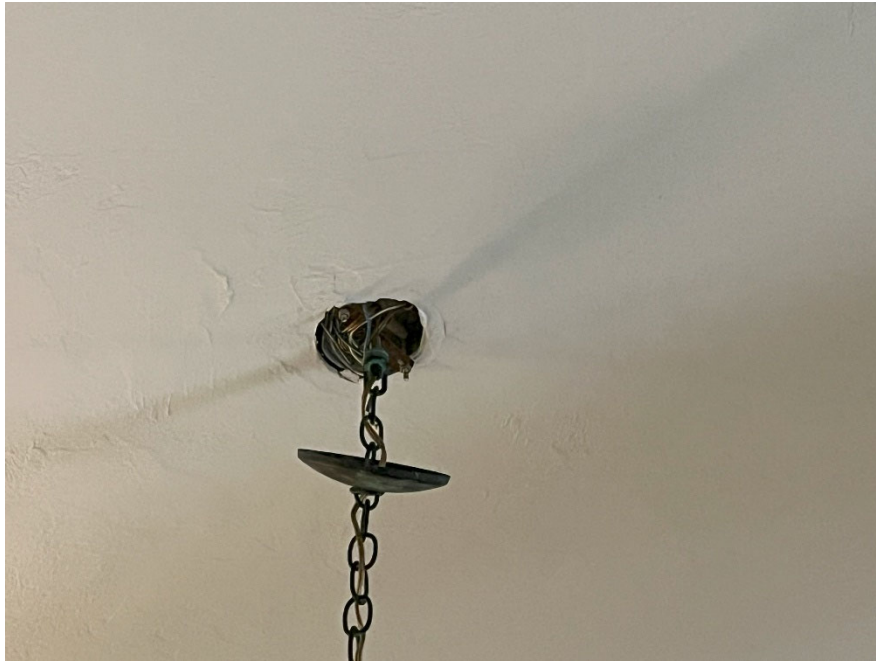
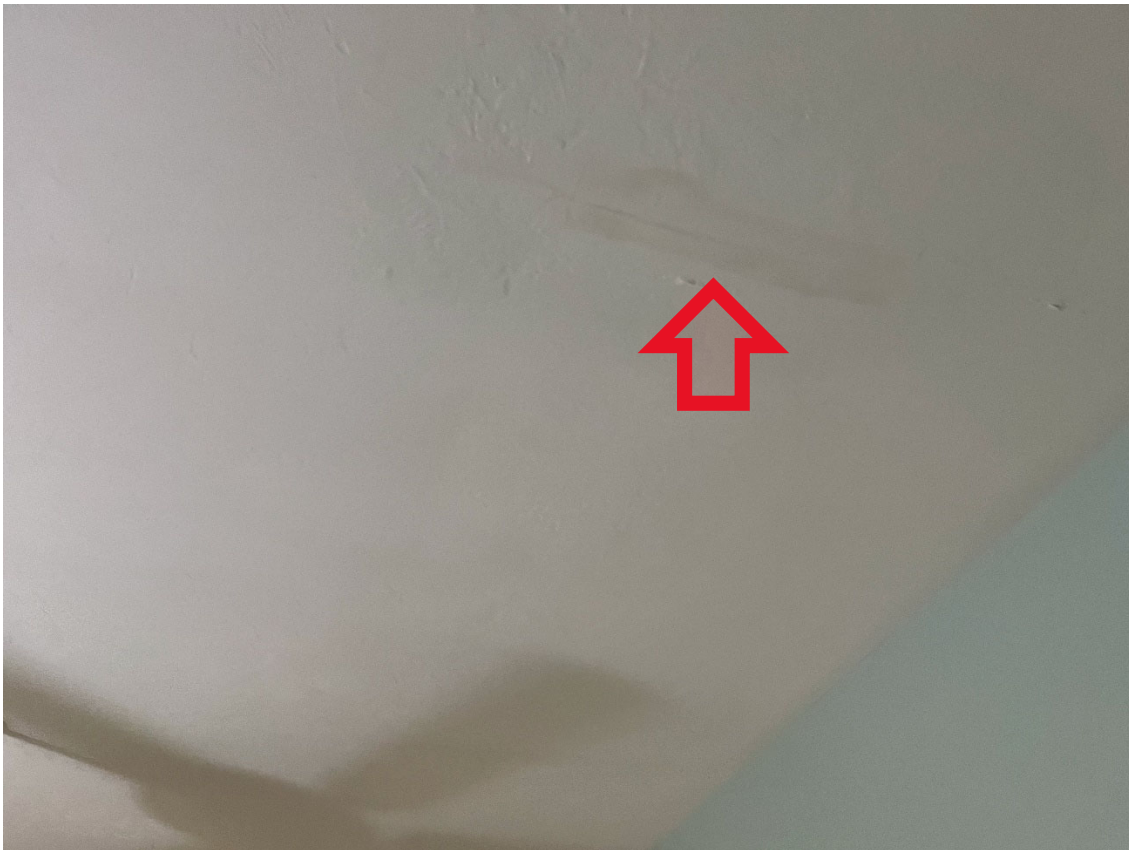
Unit 503

This unit had a loose escutcheon on the dining room chandelier. This escutcheon covers joined electrical wires and needs to be in place for safety reasons. This unit also had a water stain on the bedroom ceiling. Suggest painting over this stain to assure that water issue has been adequately addressed.

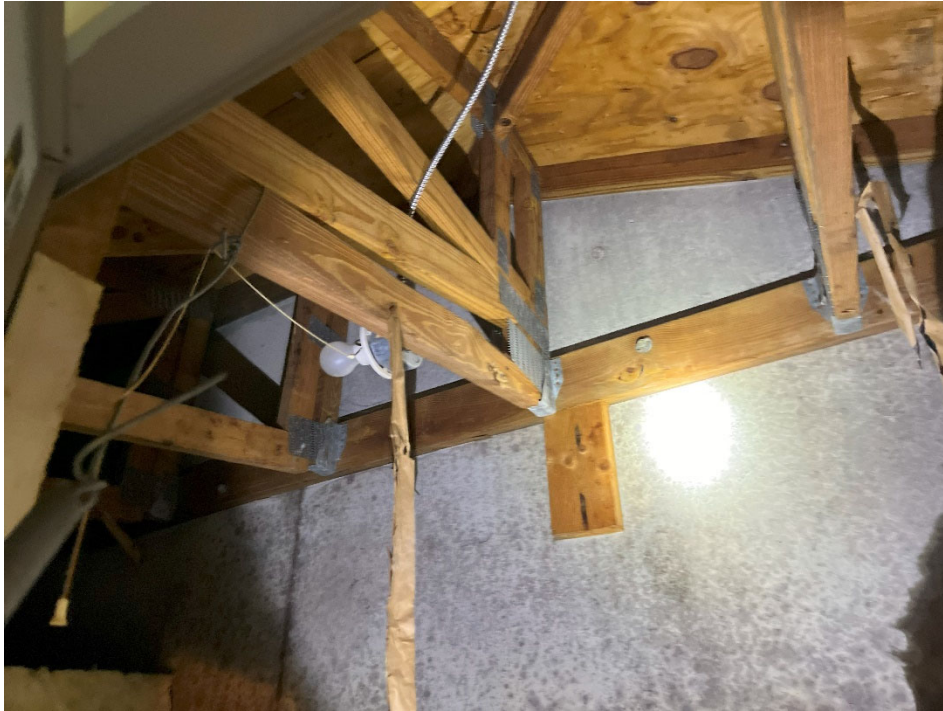
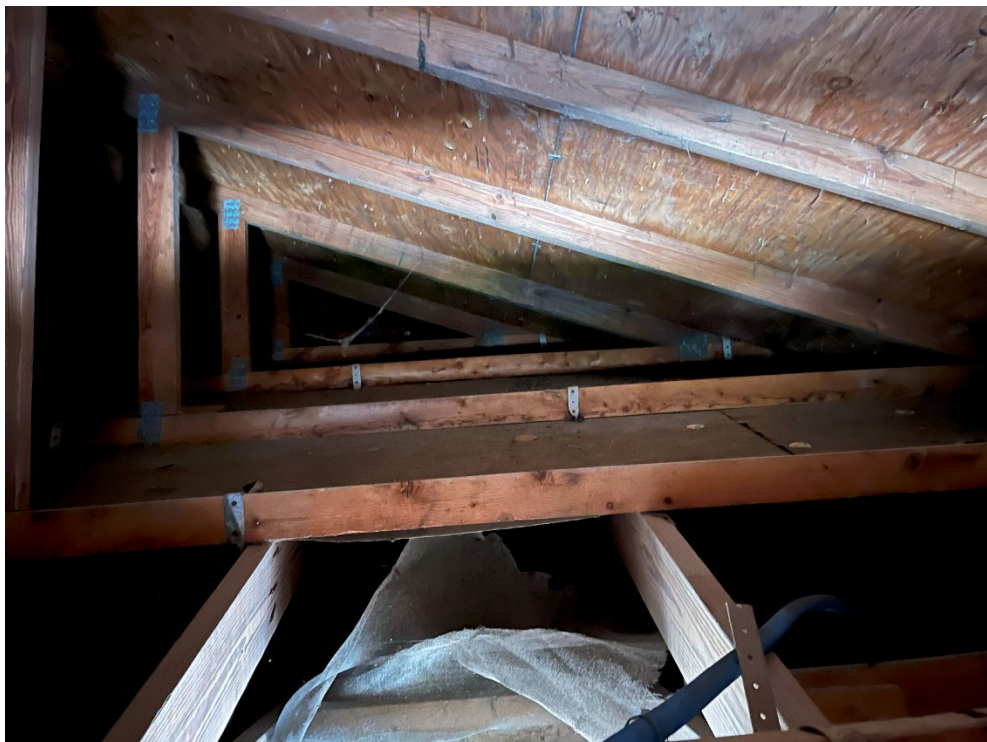
Typical Roof Framing Components

The attic was entered to assess the roof framing. Framing consisted of pre-engineered wood trusses. All appeared to be in good condition with no anomalies apparent. Required hurricane clips and tie downs were observed in place and functional. All observed gussets were tight and of adequate size for the truss.
