SECTION 1 – INTRODUCTION

PRINCETON PLACE I ON WIGGINS BAY

Report Date:
January 17, 2024

1.0 INTRODUCTION

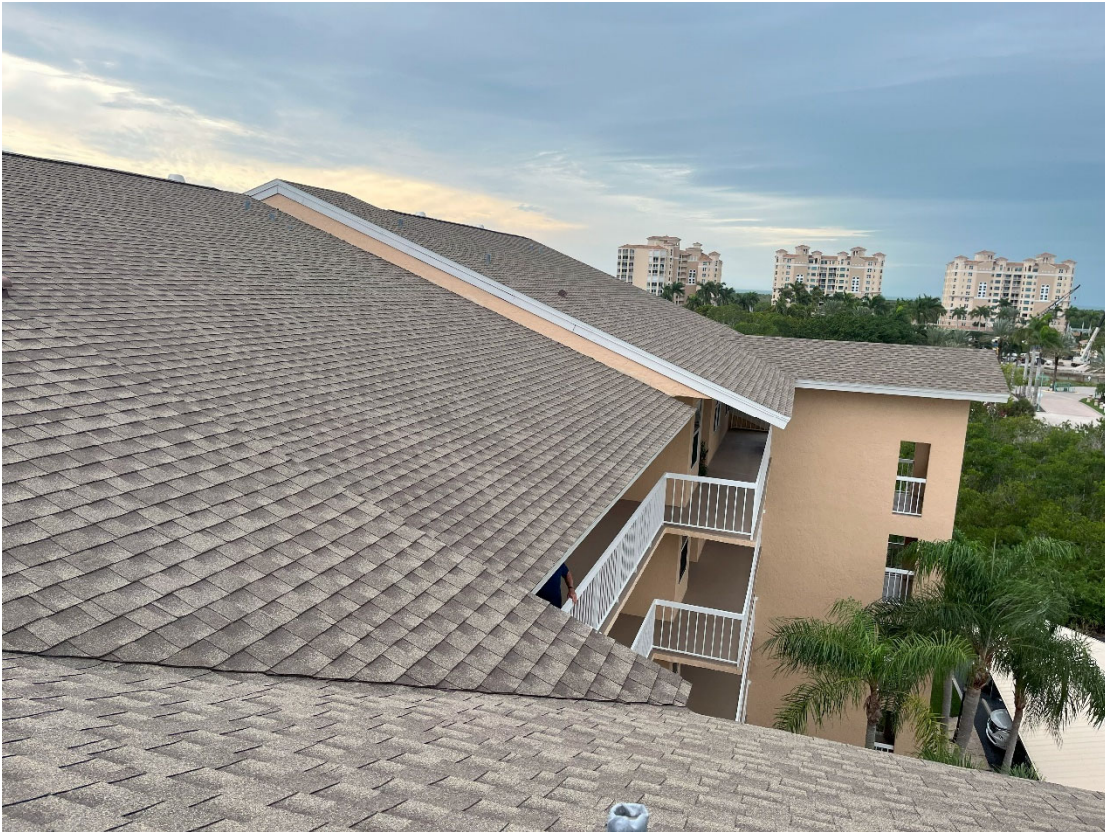
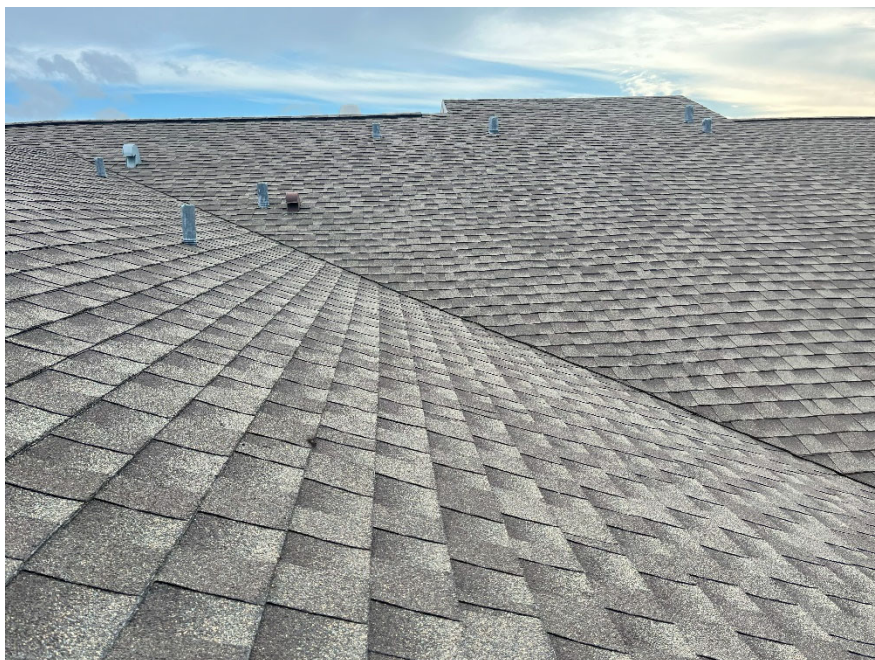
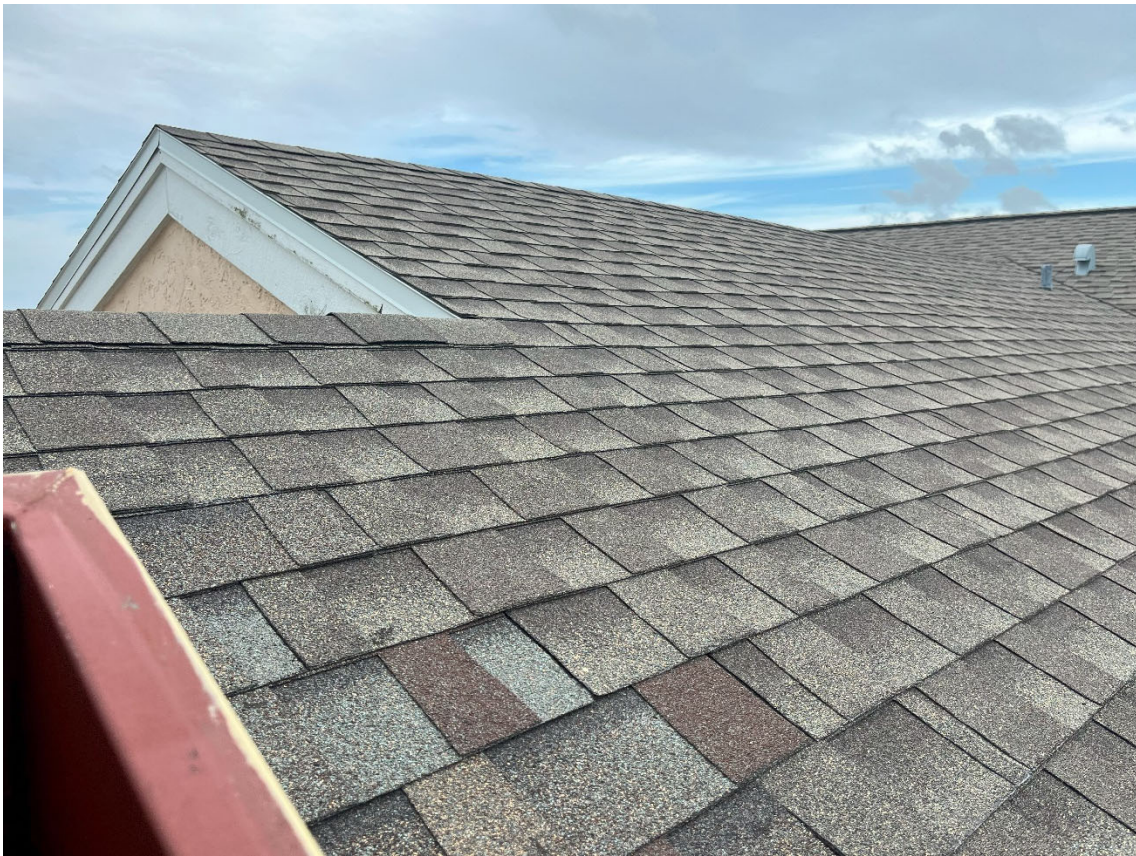
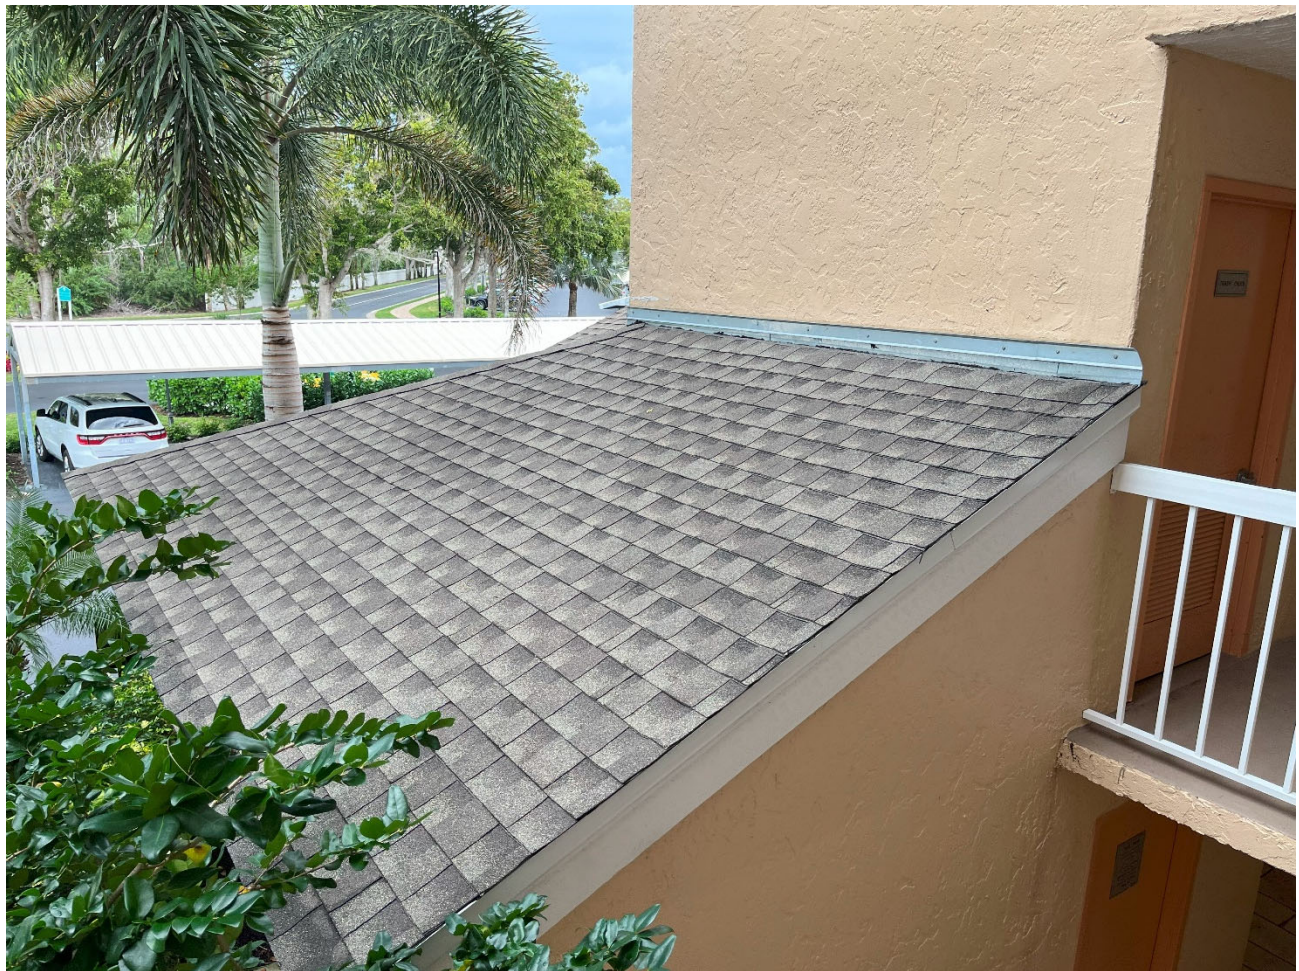
The dimensional fiberglass composition roof on this building was in excellent condition. Property Manager said the roof had been replaced in 2017 after Hurricane Irma. Roof was evaluated from the roof hatch and from the adjacent balconies but no anomalies were observed. Roof appeared to be in like new condition with a remaining life expectancy exceeding 25 years. Representative photos:
