SECTION 1 – INTRODUCTION

PRINCETON PLACE I ON WIGGINS BAY

Report Date:
January 17, 2024

1.0 INTRODUCTION

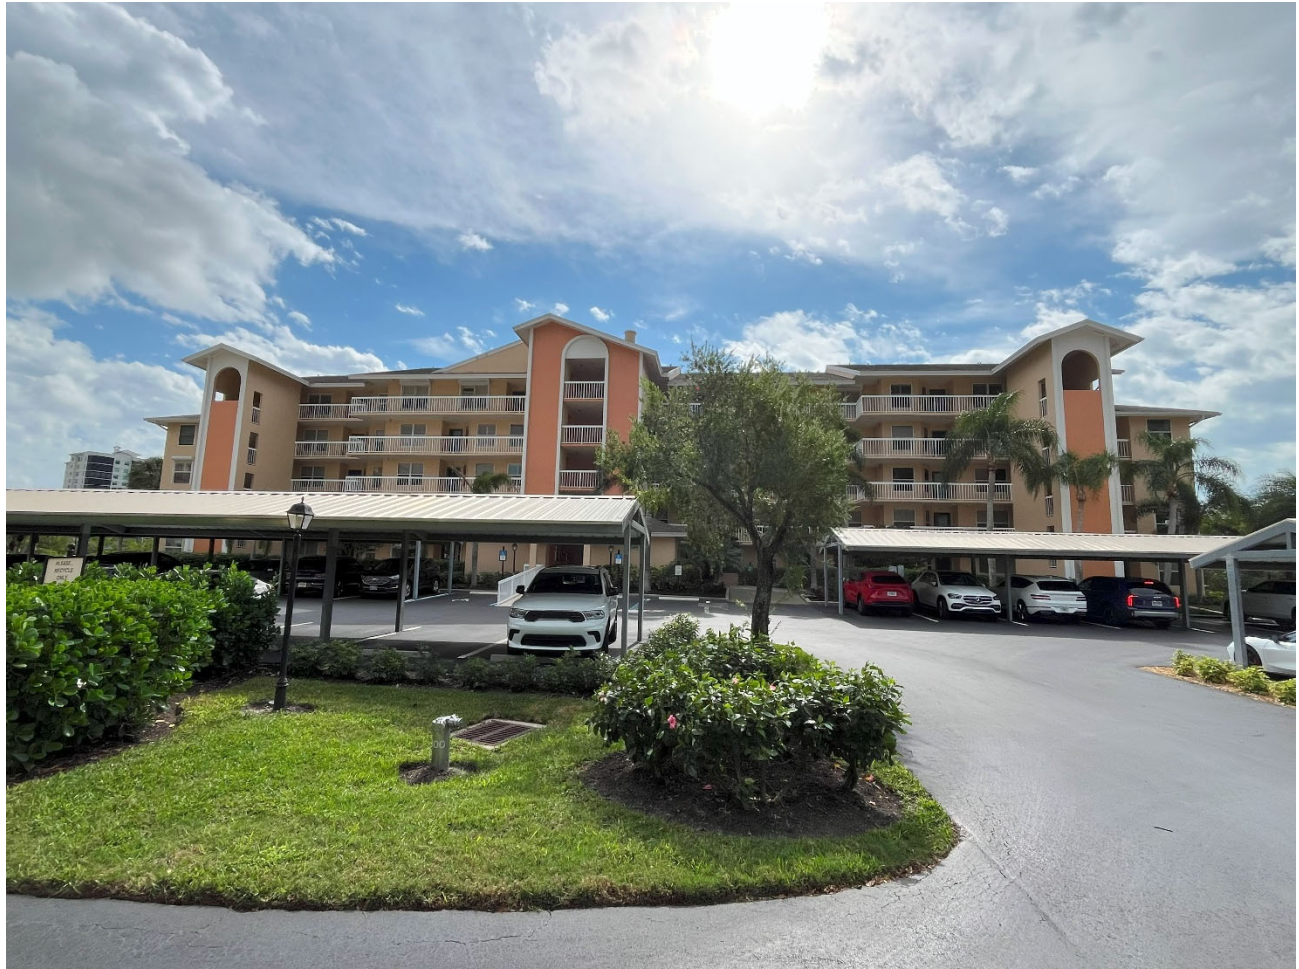
Front View

Princeton Place 1 has an exterior of cementitious stucco. Exterior is generally in good condition with no hairline cracks observed in the stucco. See comments and photos following:
